#### **TROUBLESHOOTING TOOLING SERIES**

## FACTORS TO SHORTENED LIFE

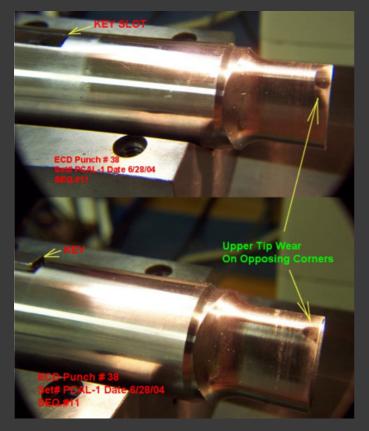
#### **MISALIGNMENT CONTACT**

Vertical wear lines indicate contact is occurring with die cavity during upper punch tip entry.

Upper punch (or setup punch) should be turned in the same direction as press rotation to "pre-set" die, and thus maintain a uniform clearance.

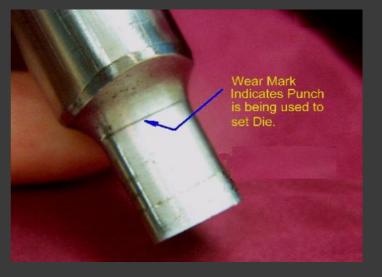
#### WEAR MARK ON TIP STRAIGHT

Punch is being used to set dies in press.

Avoid this amount of pressure in setting the dies.

Consider Elizabeth's special Triple-E (EEE) tooling and alignment punch to set dies.

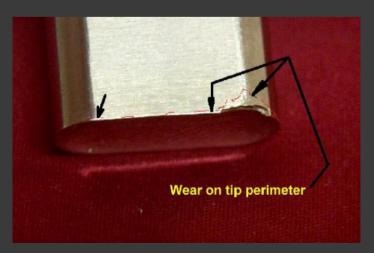
#### WEAR & BREAKAGE ON TIP

Misalignment of Punch due to worn punch guides and/or die sockets. Excessive tonnage used.

- Inspect press for wear
- Discard tool
- Run F.E.A. to determine proper tonnage.

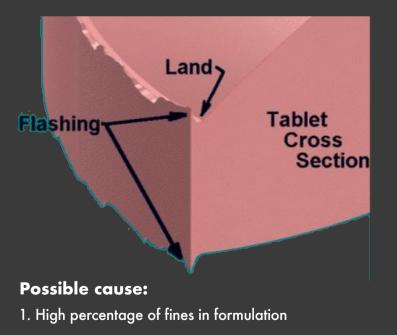
### TABLET EDGE FLASHING

- 2. Punch tip to die clearance too large
- 3. Outer punch edge wear

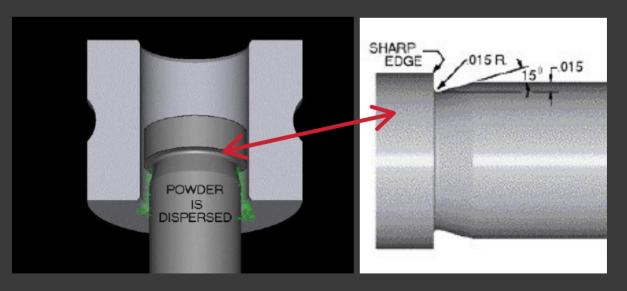
### **BAKELITE RELIEF**

High percentage of fines, high moisture content, or heat sensitive granulation.

When the tip straight edge is worn and powder is adhering to the die cavity and the tip relief, and a bakelite relief to improve the scraping action.
