PICKING & STICKING

TROUBLESHOOTING TOOLING SERIES

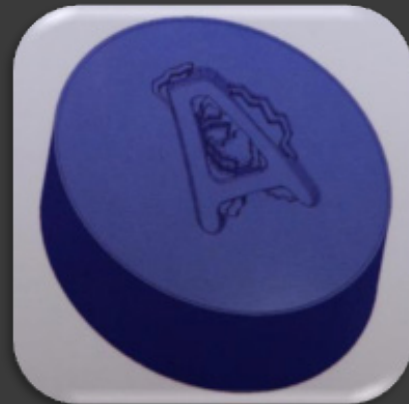
Tablet Picking

Letters and/or numbers on tablet not crisp and clear. Punch face has power adhering to the surface.

- Excessive moisture in formulation.
- Pits on punch faces and/ or improper stroke angle on embossing.
- Insufficient compaction forces. Restriction of entrapped air speed out of die cavity.
- Inadequate lubrication of granulation.

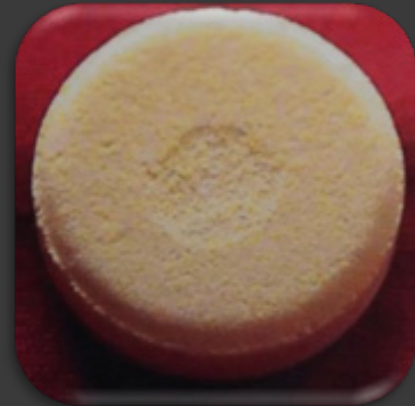
Tablet Sticking

Similar in appearance to picking in regards to powder adhering.

- Check all punch faces and die cavities for corrosion or abrasion surface conditions. May require changing steel type based on findings.
- Polish the punch face and examine if surface condition improves.
- If compression requirements rule out a steel change, consider chrome plating or coating for better wear characteristics.
